OLD RADIO

Tuned-Grid Tuned-Plate 75 Watt Transmitter

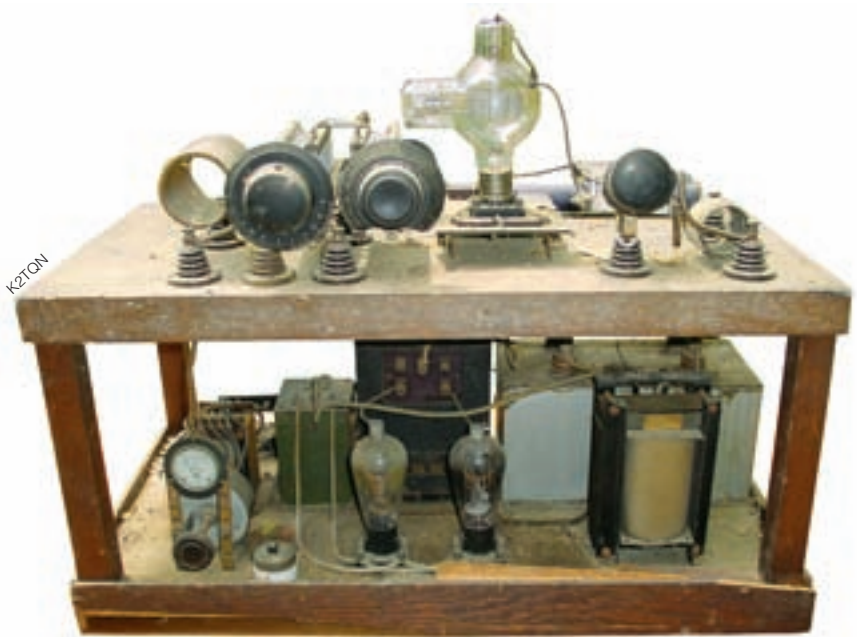
It was disappointing to find the transmitter had been damaged by rough handling. Several knobs and insulators were broken and several pieces of original wood molding had been broken as well. Also the plate lead coming out of the DeForest 52 tube was broken off at the glass line. (The large 52 tubes are rare and hard to find, I was to discover.)

Transmitter as found with broken knobs, insulators, and 52 tube plate lead and broken trim moldings.

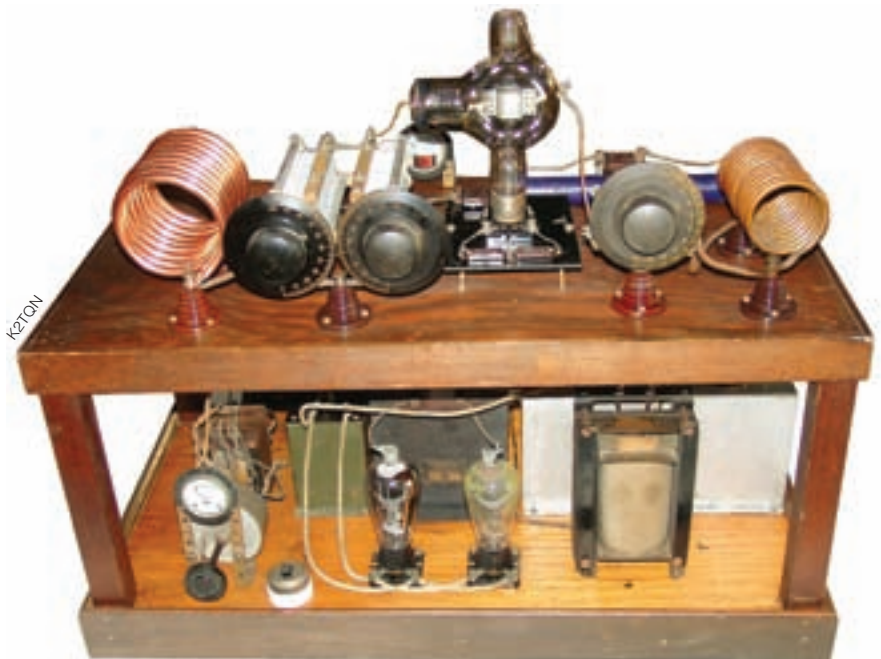
Restored transmitter with new knobs, new 52 tube, tube socket and new trim moldings.
